# Factual Update

October 16, 2019

## Incident Summary

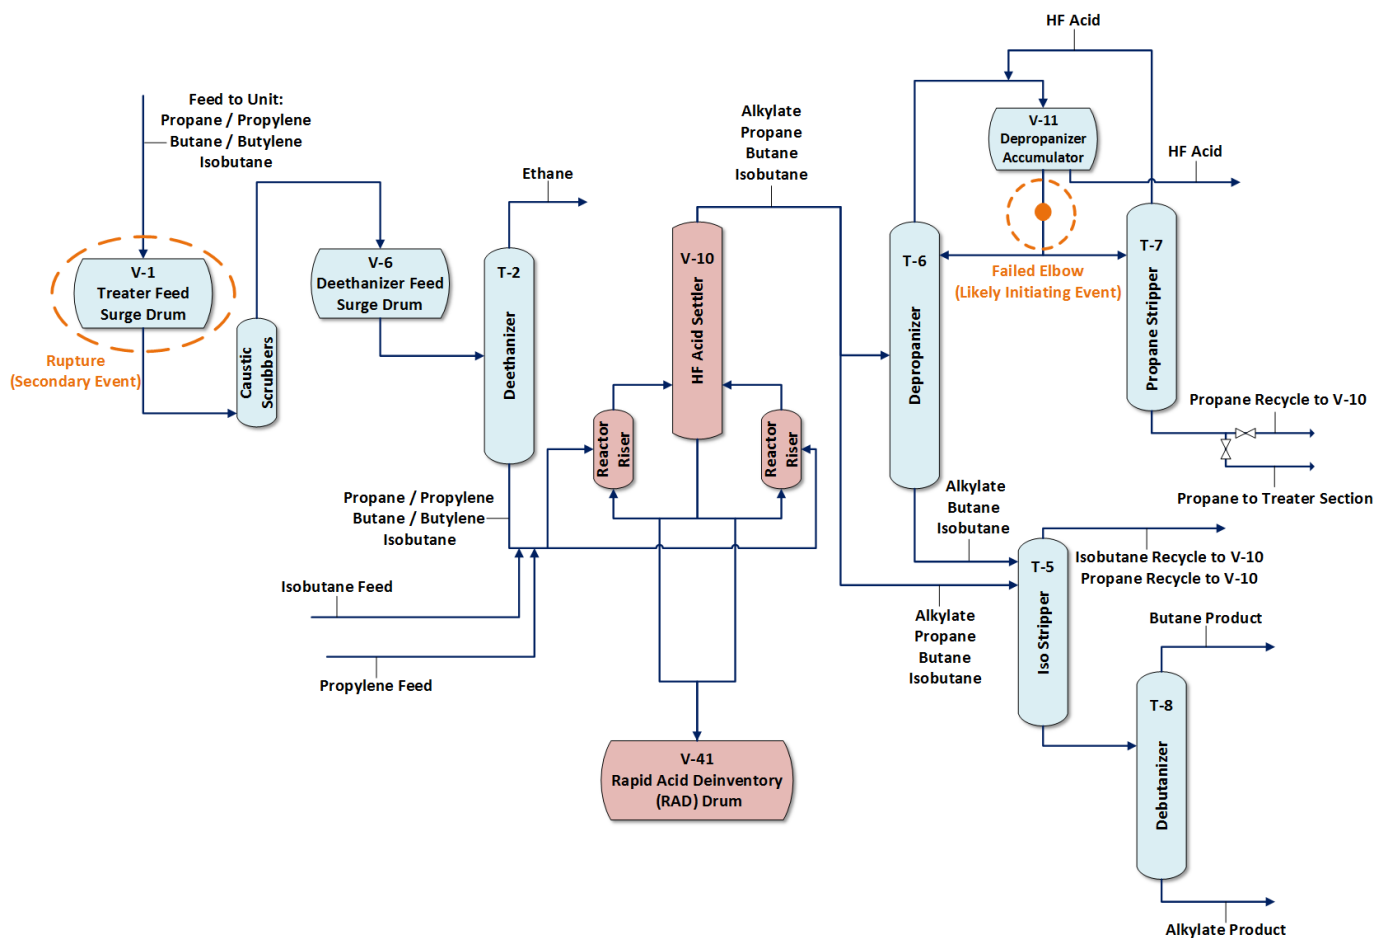
- A process flow diagram of the PES hydrofluoric acid alkylation unit is shown in Figure 2. Indicated on the process flow diagram in orange are two equipment failure locations of interest. These identified failures are discussed below.

Figure 2. Process flow diagram of PES hydrofluoric acid alkylation unit. The equipment shown in red is the hydrofluoric acid alkylation reaction section and the Rapid Acid Deinventory (RAD) drum, to which the hydrofluoric acid can be routed. (Credit: CSB).

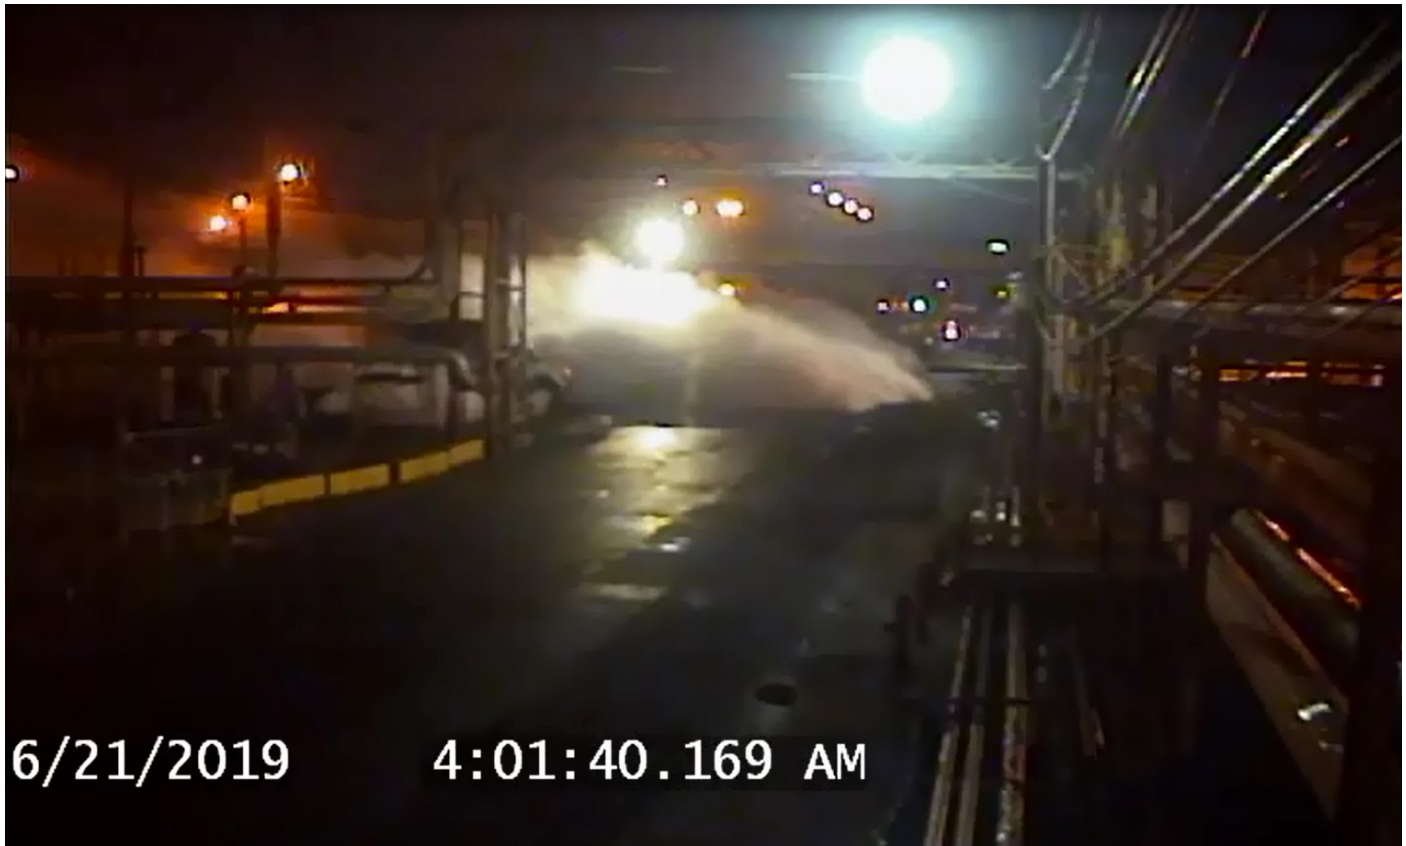
- During the early hours of Friday, June 21, 2019, the HF alkylation unit was reportedly operating normally.
- At 4:00:16 am, there was a sudden loss of containment causing flammable process fluid containing hydrofluoric acid to release from the PES alkylation unit, forming a ground-hugging vapor cloud (Figure 3).

Figure 3. Security camera footage of leaking process fluid. It formed a large ground-hugging vapor cloud that surrounded some sections of the unit. (Credit: PES).

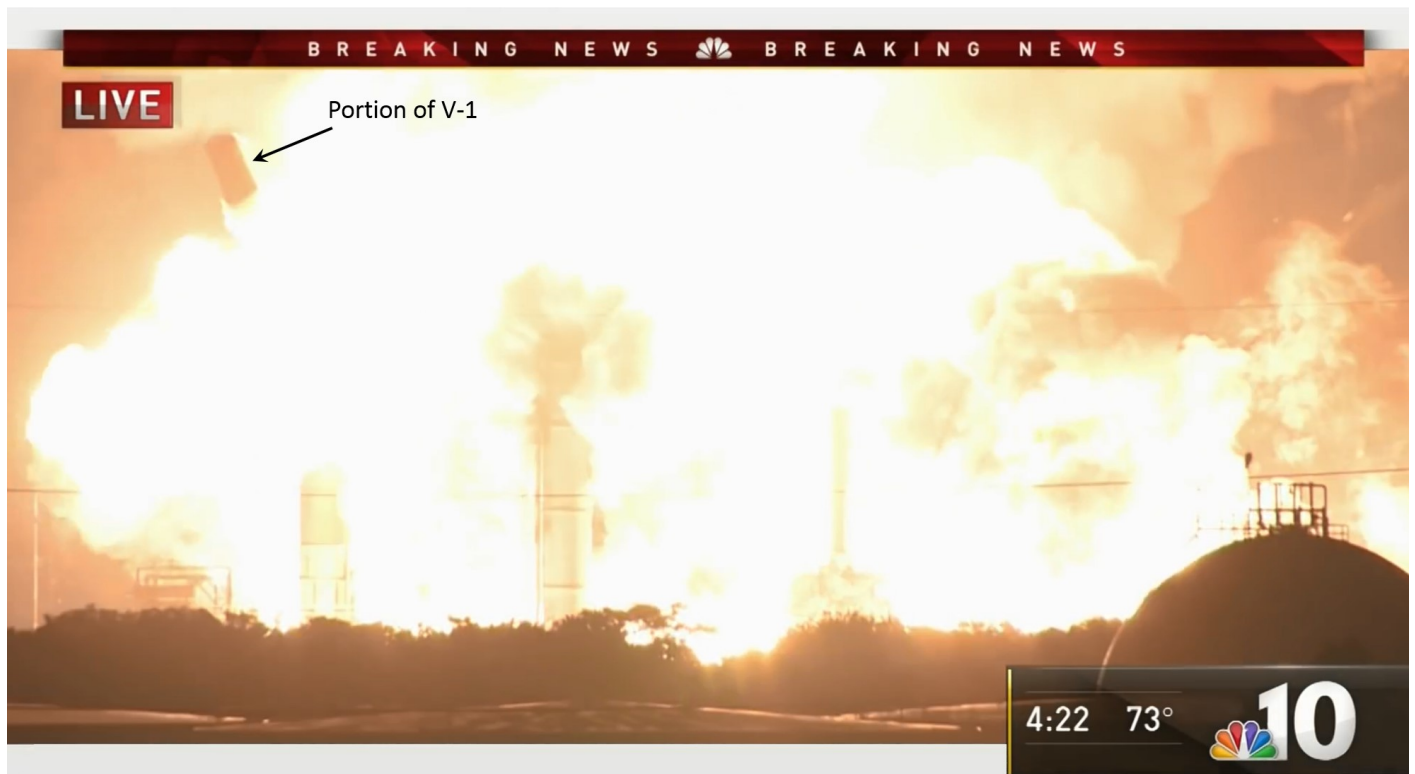
- At 4:15 am, during the ongoing fire, an explosion occurred in the alkylation unit. A second explosion in the unit then occurred at 4:19 am.
- At 4:22 am, a third, and the largest, explosion occurred when the V-1 Treater Feed Surge Drum, containing primarily butylene, isobutane, and butane, violently ruptured (Figure 4, Figure 5). A fragment of the vessel weighing approximately 38,000 pounds flew across the Schuylkill River, and two other fragments, one weighing about 23,000 pounds and the other 15,500 pounds, landed in the PES refinery (Figure 6). This appears to be a secondary event caused by the fire.

Figure 4. Video still of V-1 explosion. (Credit: NBC10 Philadelphia<sup>a</sup>).

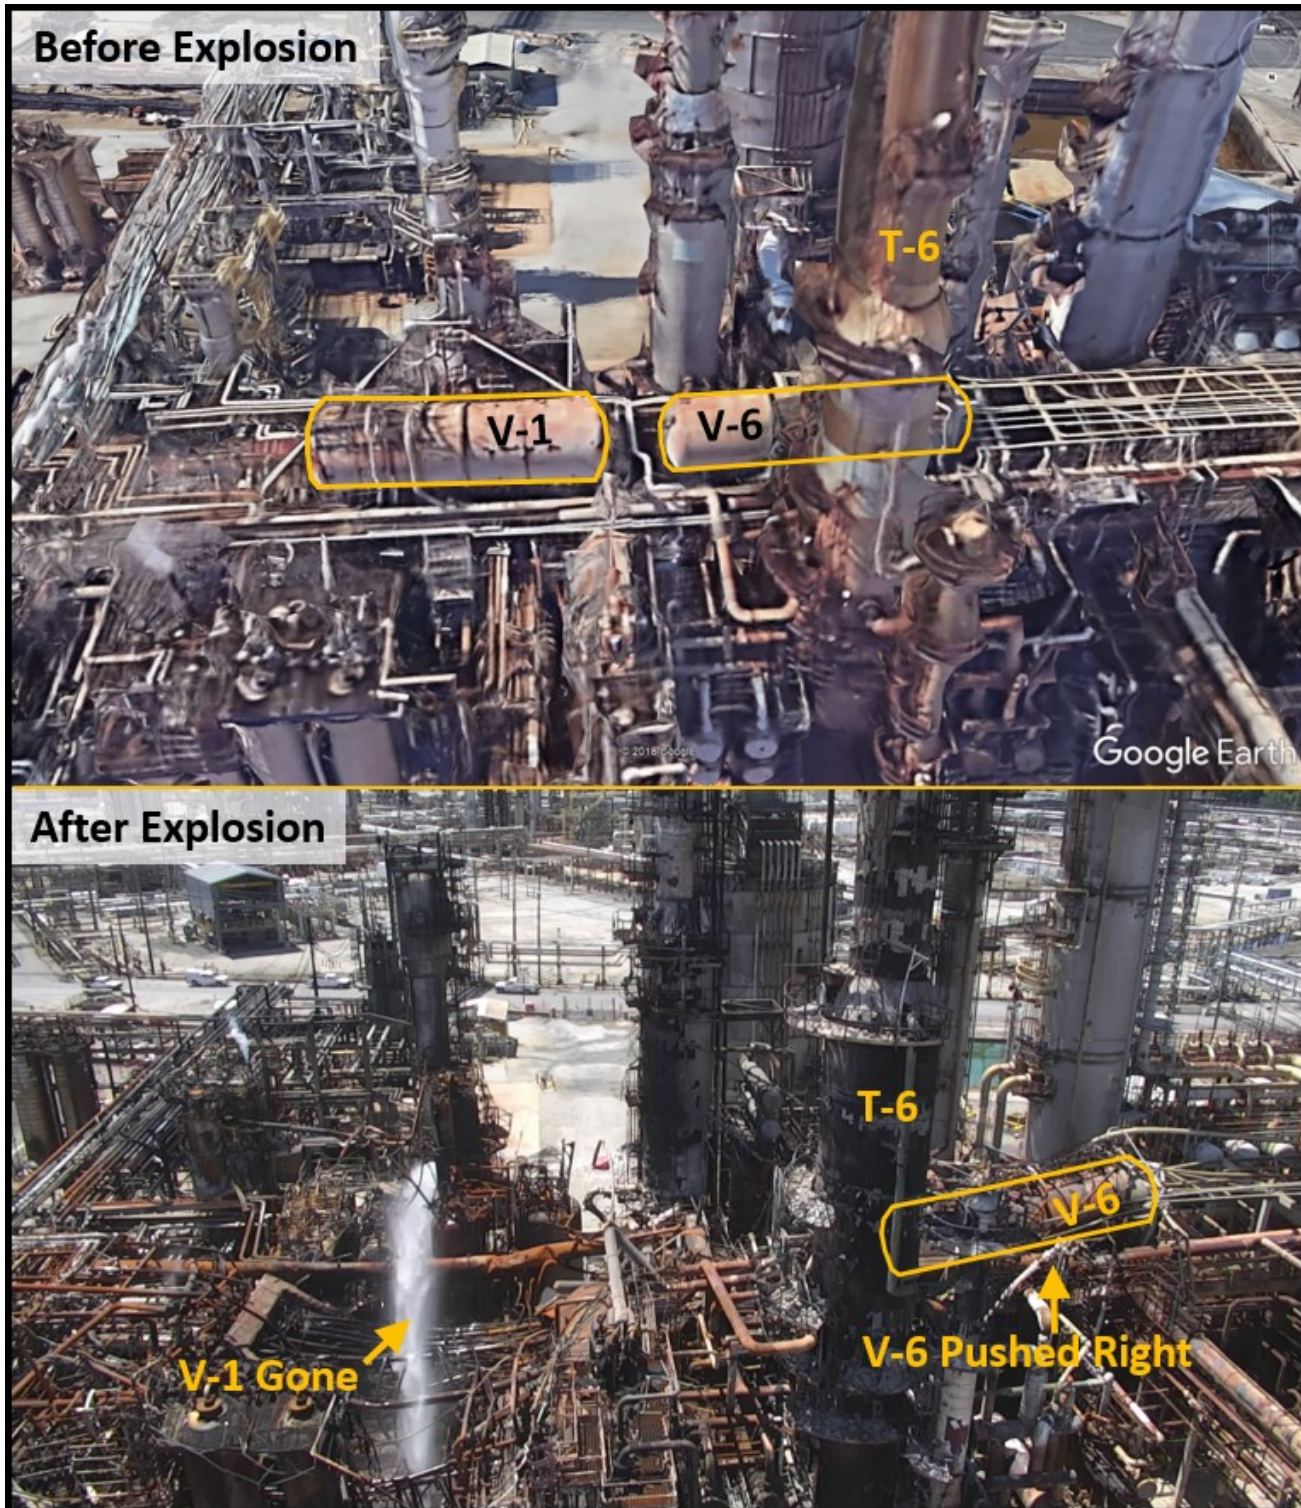
Figure 5. Comparison of incident scene pre-and post-incident. (Top photo credit: Google Earth. Bottom photo credit: PES. Modifications by CSB).

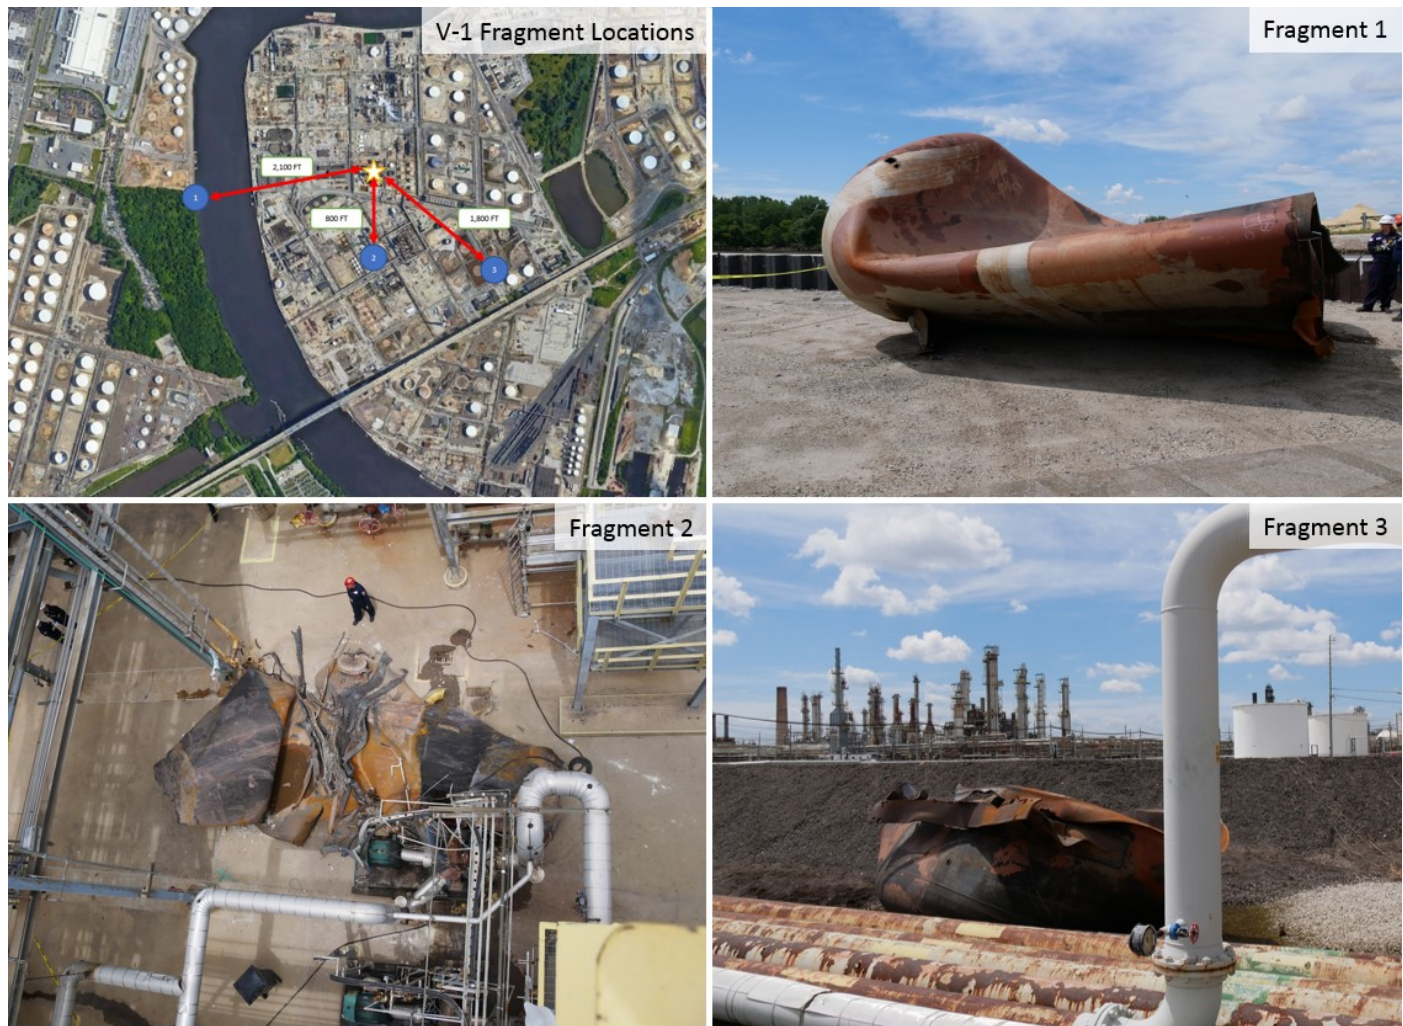
Figure 6. Locations and photos of the post-incident V-1 vessel fragments. The fragment 1 photo was taken after the fragment was recovered from the bank of the river and relocated to the PES refinery. The deformation of fragment 1 was likely caused by impact with the river bank. (Top left photo credit: Google Earth with modifications by CSB. Credit for other photos: CSB).

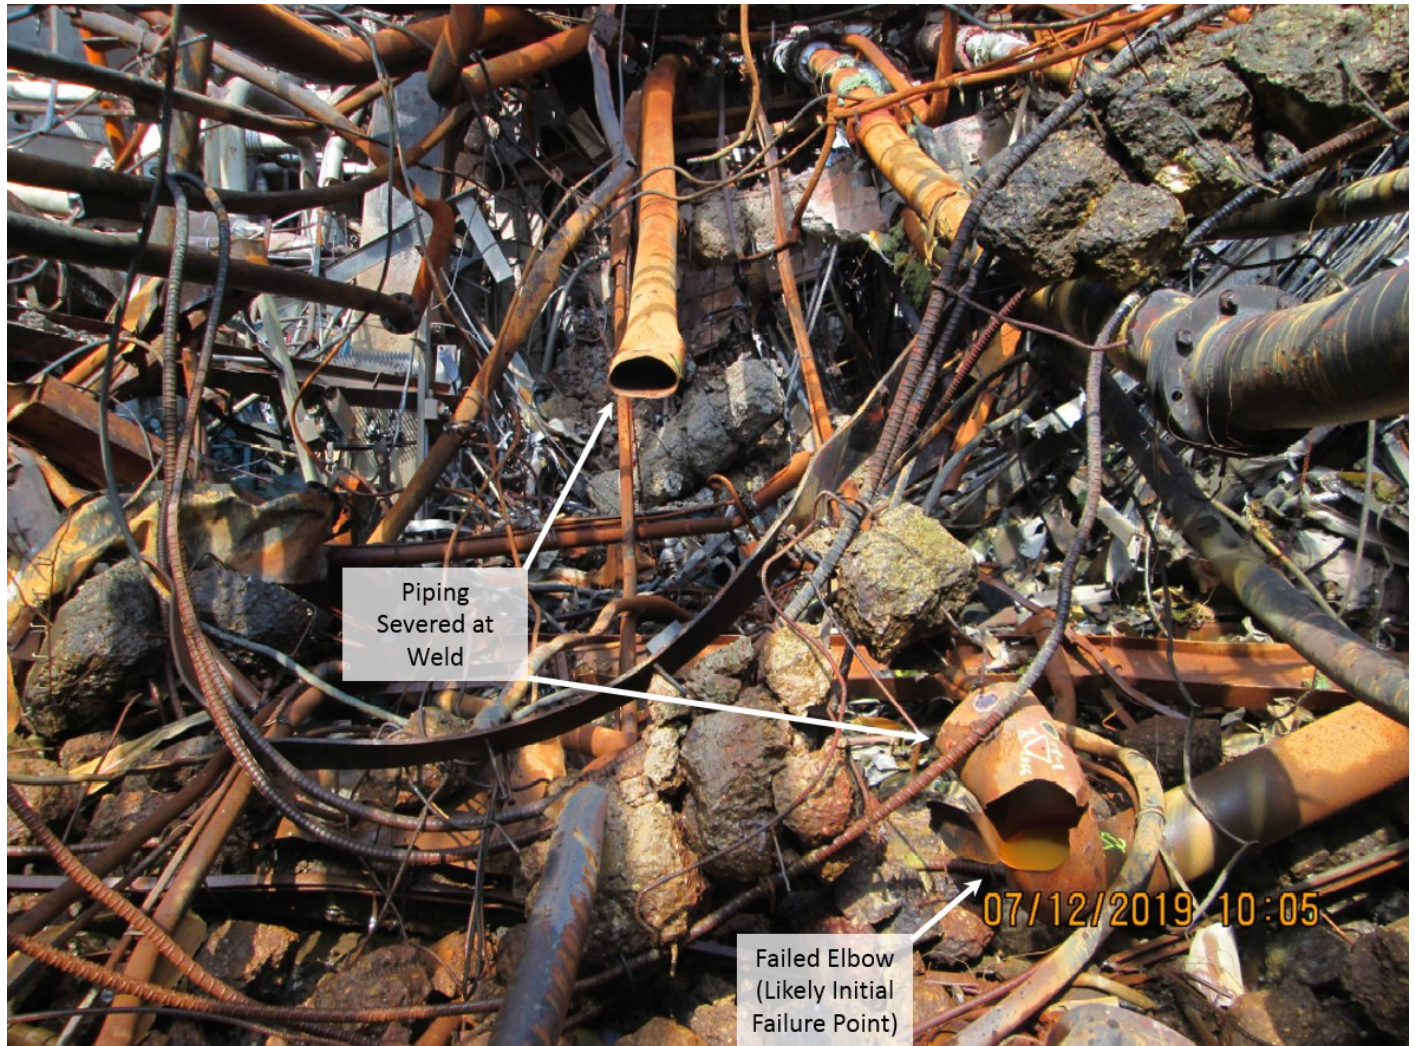
- A ruptured pipe elbow was found in the unit post-incident (Figure 7). The rupture of the elbow appears to be the initiating event causing the process fluid release. The elbow was part of the piping between V-11, the depropanizer accumulator, and T-6, the depropanizer distillation column. The elbow was on the discharge (outlet) piping from a pump (one of two pumps in this system) that was not operating at the time of the incident. At the time of the event, this piping was operating at a pressure of about 380 psig and a temperature of about 100 °F. The approximate design composition of process fluid in the piping was:

Figure 7. Photo of ruptured pipe elbow found post-incident. (Credit: PES).

- A CML was not located on the ruptured elbow, so the thickness of this elbow was not monitored. The thinnest measurement taken of the ruptured elbow post-incident was 0.012 inch.<sup>b,c</sup> This value is less than 7 % of the PES default retirement thickness.

- The piping circuit containing the ruptured elbow was installed in about 1973. As of this Factual Update, this piping appears to be the original piping. Both the elbow that failed and the adjacent elbow are stamped “WPB”, indicating they were constructed to meet the ASTM A234 WPB material specifications.

- The 1965 version of ASTM A234 *Standard Specification for Factory-Made Wrought Carbon Steel and Ferritic Alloy Steel Welding Fittings*, the applicable version at the time of the pipe installation, required that Grade WPB pipe “permissible raw materials” composition meet the A106 Grade B chemical composition specifications. The 1972 ASTM A106 standard did not specify nickel (Ni) and copper (Cu) composition requirements. In 1995, ASTM A234 began specifying nickel and copper composition, as well as compositions of other elements.<sup>a</sup> The WPB composition requirements in 1972 and 1995<sup>b</sup> are shown below. The chemical composition of the ruptured elbow and the adjacent elbow are also shown. The nickel and copper content of the ruptured elbow exceeds the updated A234 WPB chemical composition requirements.

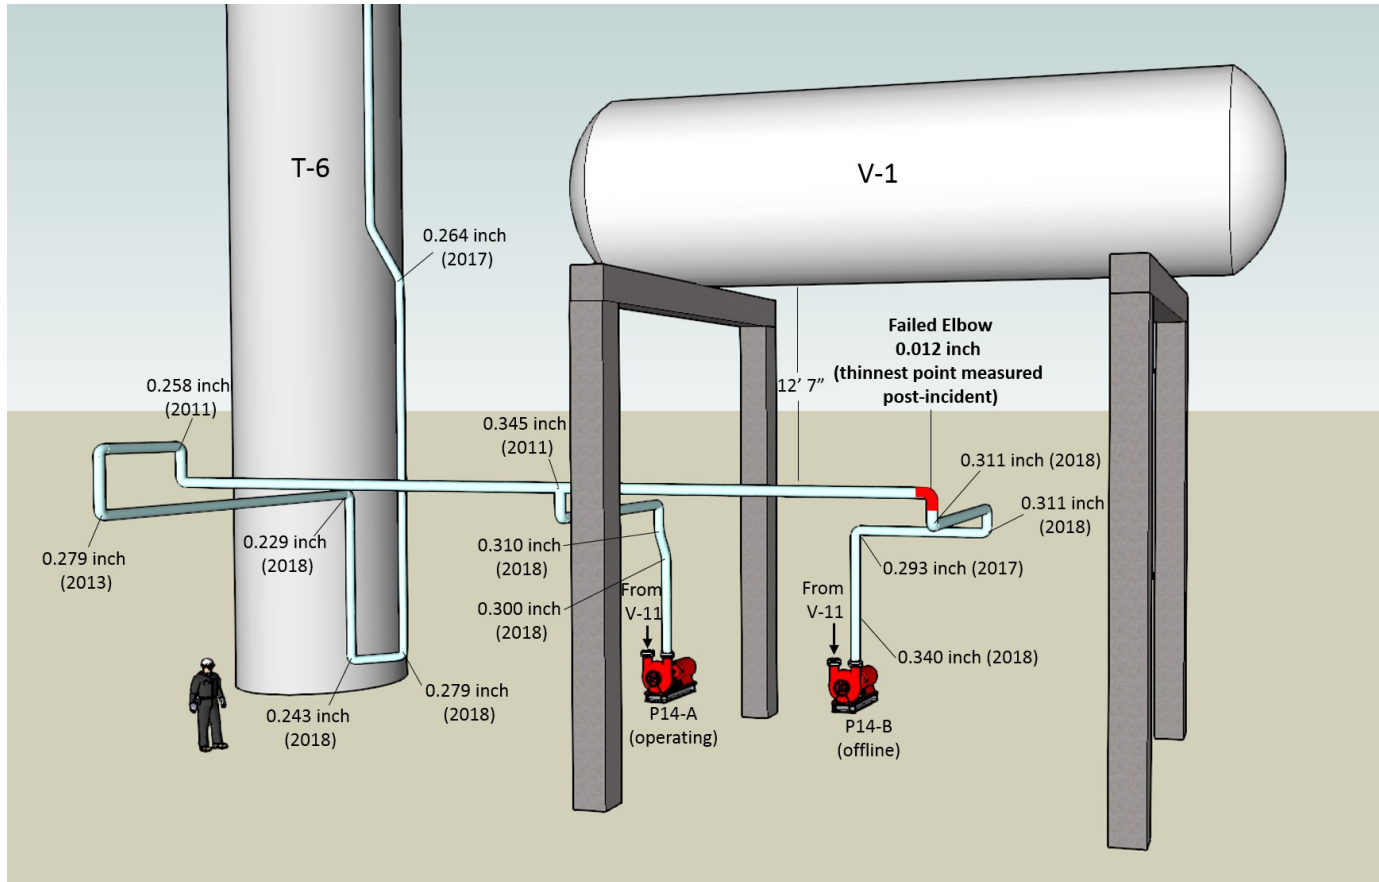
- The piping circuit that includes the ruptured elbow was subject to regular ultrasonic thickness measurements at designated condition monitoring locations (CMLs),<sup>a</sup> as part of the PES inspection program to monitor the rate of piping metal loss due to corrosion. Locations of CMLs and the most recent thickness measurements are

shown in Figure 8. The default retirement thickness<sup>a</sup> of this piping in the PES inspection database is 0.180-inch. The most recent CML measurements did not indicate thin pipe.

Figure 8. Model of the piping circuit containing the ruptured elbow. The most recent thickness measurements at designated Condition Monitoring Locations (CMLs) are shown. The year of each measurement is shown in parentheses. This figure also illustrates that V-1 was directly above the ruptured elbow. (Credit: CSB).
